TOP 10 RED FLAGS

Understand what issues your homebuyers are on the lookout for and how to offer solutions.

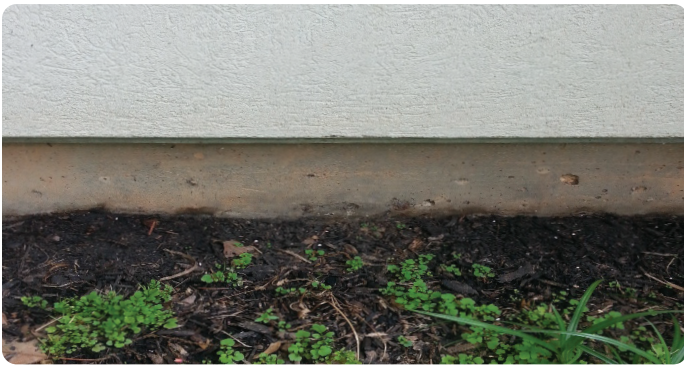
Right.

High grading around the foundation is one of the most common issues identified on inspection reports. The proper minimum clearance between the facade and the soil is 4 to 6 inches. High grades are most commonly found in planter areas. Homeowners often place new mulch without removing the old, creating potential issues.

Drainage problems are avoidable with proper grading. Site grading should always slope away from the foundation for at least 5 feet. Gutter downspouts should always direct the water at least 5 feet away from the foundation or deposit into a site drainage system.

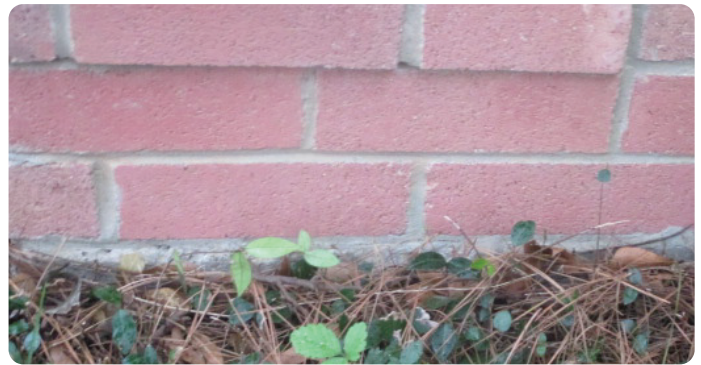
Wrong.

Ponding water around a foundation can cause a loss of support and settlement. When water sits against the foundation without proper drainage, the ponding can result in wood rot and mould throughout the structure.

Siding, stucco, and stone/brick veneers are not waterproof, so water easily penetrates the exterior walls. High grading can obstruct the weep holes that allow the moisture to escape. If the drainage is blocked, the moisture gets trapped in the wall, promoting more wood rot and mould.

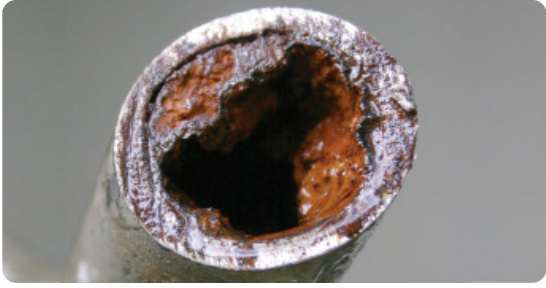
"Galvanized" pipes are zinc-coated pipes that were meant to prevent rusting. Galvanized piping was common until the 1950s and lasts around 40 to 60 years.

When galvanized pipes are found today, they are usually near the end of their lives and in need of replacement.

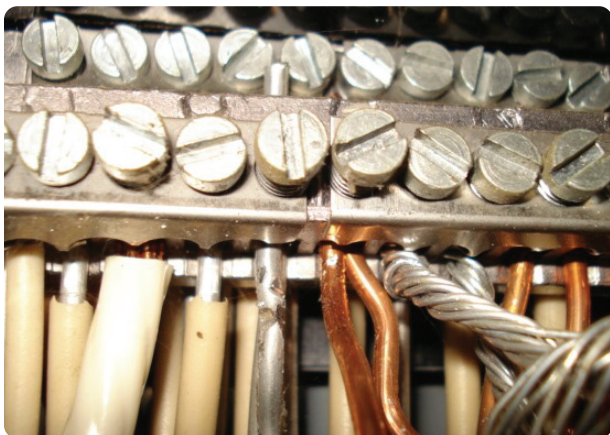
Aluminum Branch Circuit Wiring

Aluminum branch circuit is a permitted method of wiring with the appropriate installation methods and materials. However, careful workmanship is required because of aluminum's unique electrical properties and its delicacy. Poor workmanship has led to many improper connections, which result in overheating and fire hazards. These systems face the same insurance-related problems as knob and tube systems. If improper connections were made, repairs are possible with a highly skilled technician.

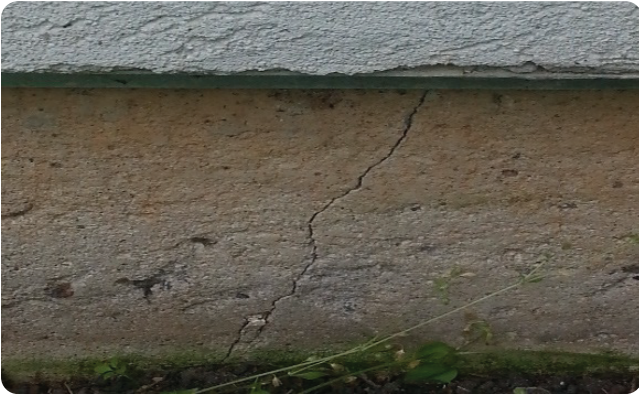
Hairline Cracks (1/16 inches or Less)

Hairline cracks are most likely caused by shrinkage during the curing process of poured concrete. They do not present any concern.

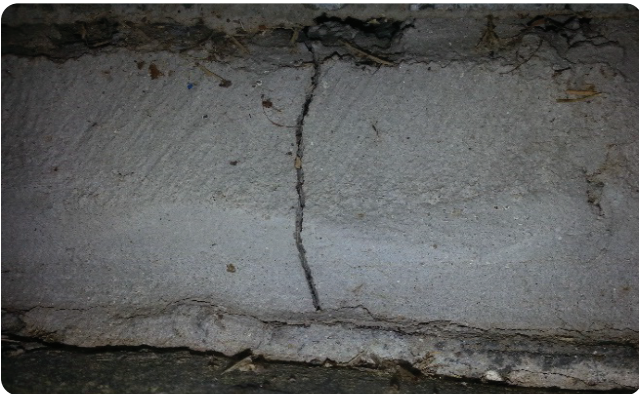
Cracks 1/8 inches or Less

Cracks this size may indicate either shrinkage from curing or foundational movement. This crack should be sealed and monitored.

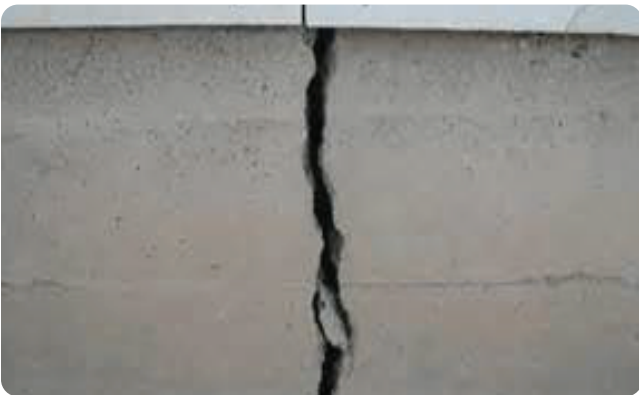
Cracks 1/4 inches or More

Cracks this large are most likely due to foundational movement. A structural engineer should be consulted.

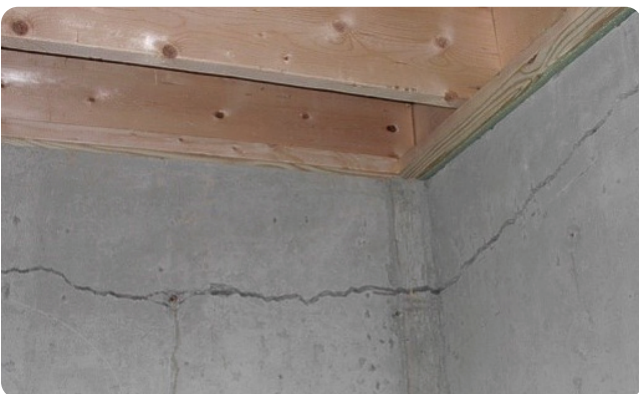
Basement Foundation Walls

Horizontal cracks found in the basement can be minor or major. Some minor cracks may be repairable DIY-style. Depending on their width and severity, some cracks may require stabilization repairs such as wall tiebacks or carbon fiber reinforcement. An GPI inspector would typically suggest a consultation with a structural engineer.

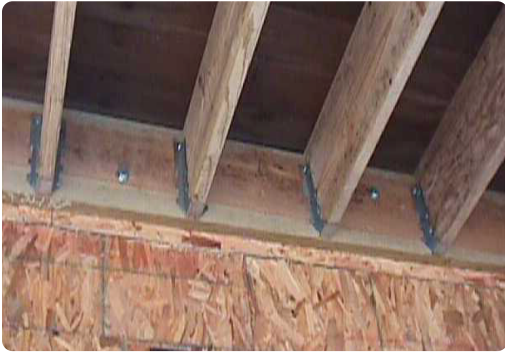
Poor deck conditions are often visible to untrained eyes. Check for post deterioration or chipped paint. Less obvious red flags exist in a deck's support system. Unstable support is often characterized by uneven or sloped boards. Industry standards require all ledger boards be bolted to the house, and joist hangers must be installed on every joist with the appropriate type and amount of fasteners (left). All decks should have adequate fall protection including handrails and spindles.

Most deck issues can be self-repaired by a homeowner. For any structural concerns, a homebuyer can request an engineer consultation. Deterioration can be prevented with adequate maintenance and updated sealant.

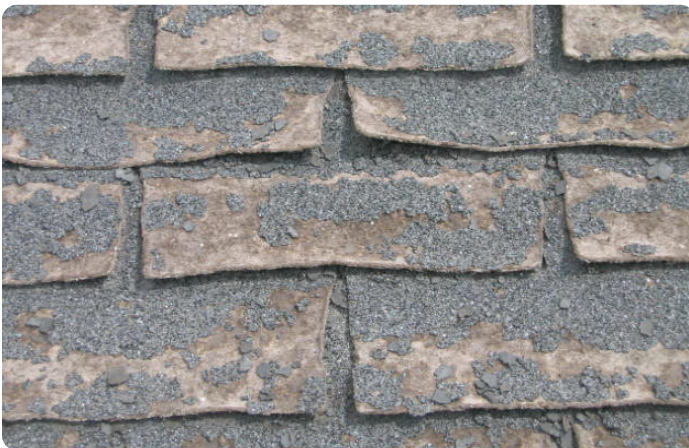
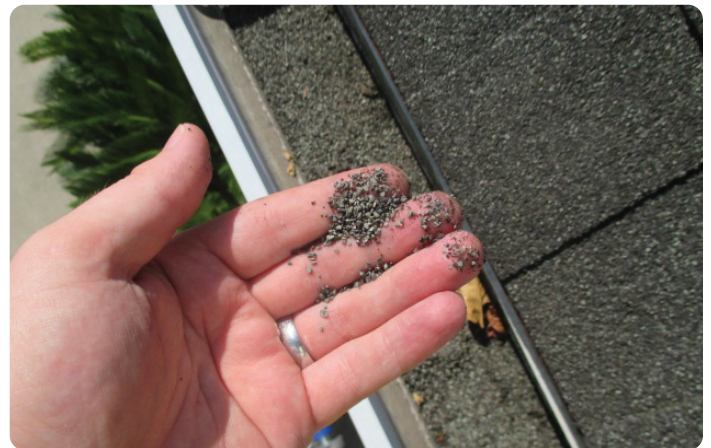
Roof condition is often a key factor in home appraisal. Excessive granular loss (pictured above) is a key indicator of poor condition. Note that the south-facing side of a house always displays the most wear.

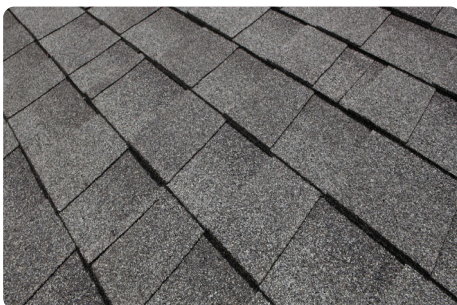
New, 0-5 years

Little to no granular loss, No cupping or curling, Straight edges

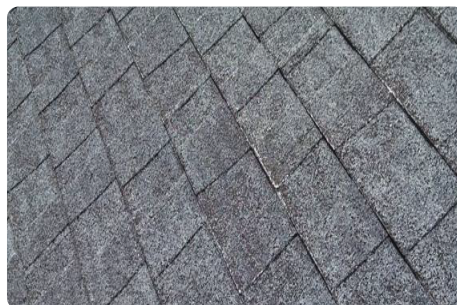
Medium Wear, 5-15 years

Mild to moderate granular loss
Some cupping or curling

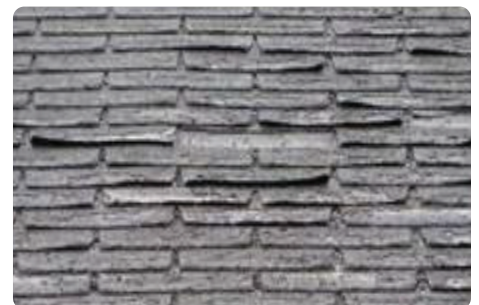
Heavy Wear, 15+ years

Excessive granular loss, Excessive cupping or curling, Deformed edges

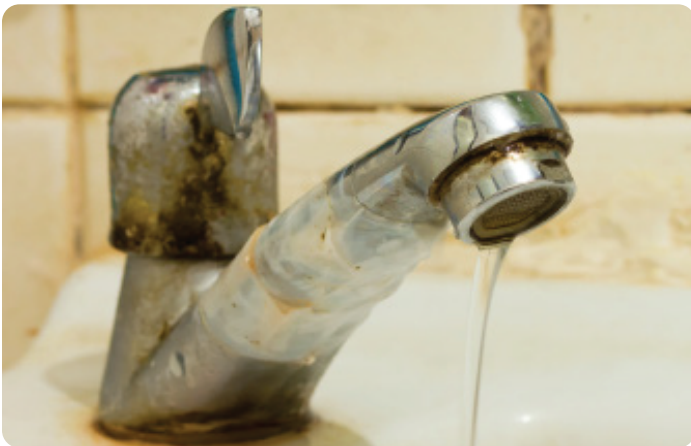
Mould will grow anywhere that excessive moisture is present. It eats paper and wood materials within a home. Still, mould should be treated on a case-by-case basis to determine severity. Small amounts of mould and mildew around showers, tubs, and sinks are normal (above, left). Small amounts of mould on window sills are normal and most likely caused by condensation. These do NOT present a major problem or concern.

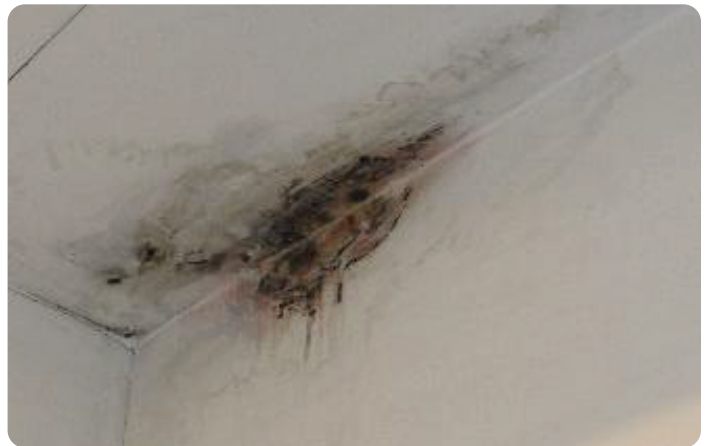
However, mould found on walls or ceilings outside of a kitchen or bathroom DOES signal a problem (above, right). Typically, this indicates a roof or plumbing leak. Any amount of mould to the sides or below a window or door indicates a leak as well. These are definitely a major problem.

If you suspect a home has mould, encourage the owners to schedule a mould inspection immediately. Locating mould as soon as possible is key to saving thousands of dollars.
